sinclair

QL

Service Manual

Prepared by THORN (EMI) DATATECH LTD
for SINCLAIR RESEARCH LTD

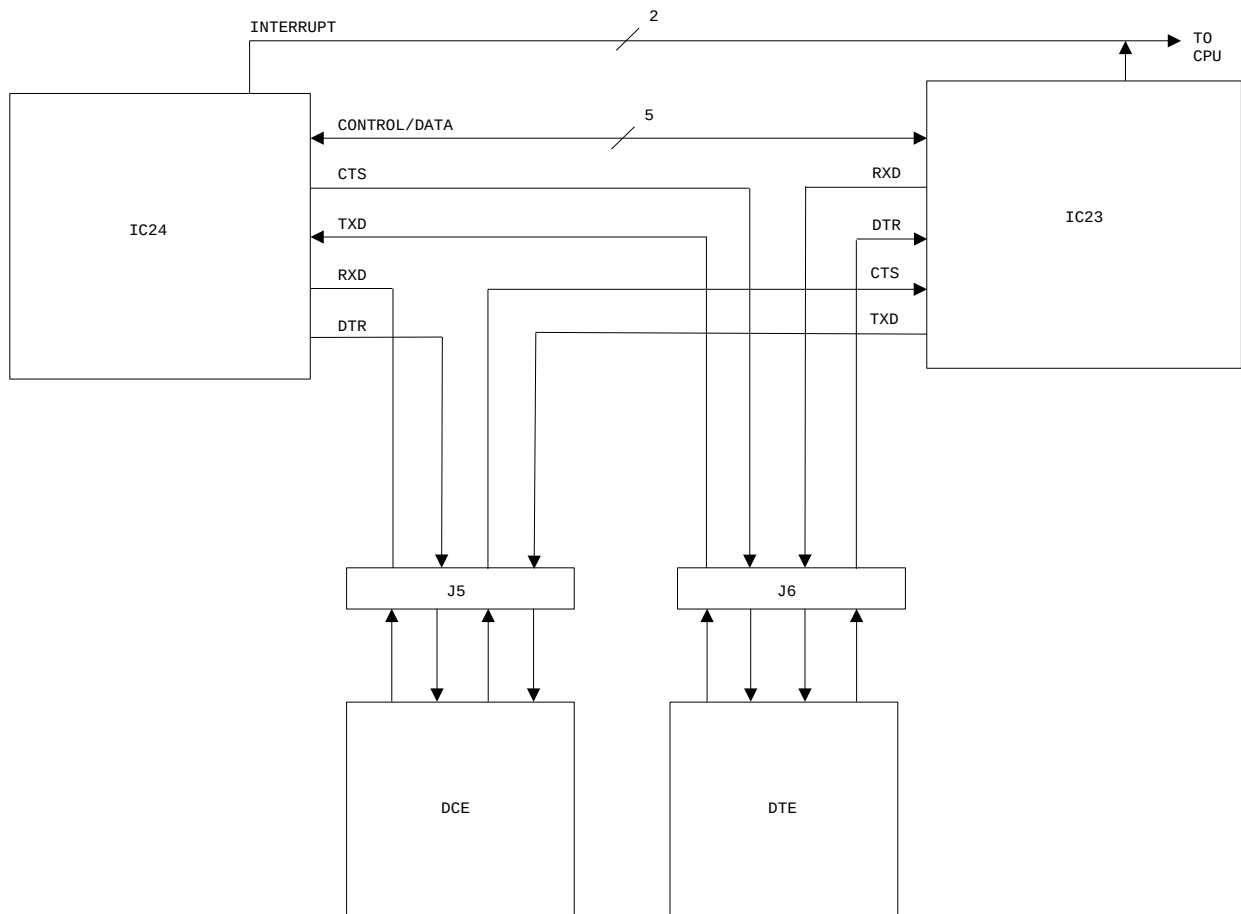
Figure 1.1 RS232 LINK

- 4.8. Consider the QL as the DTE. Both DTE and DCE are switched on and have their DIR signals asserted. CTS and DTR (Clear to Send, Data Terminal Ready) do not form a handshake pair but are similar signals going in opposite directions. Serial data is transmitted by IC23 via driver IC25/6 and received by line receiver IC26/11. From IC26/11 data is fed to NAND gate IC27/9, pin 10 of which is set to the high state by the program, and input to IC24 pins 6 and 21 via IC27/11.

- 4.9. On receipt of a start bit, IC24 is interrupted, and a subroutine clocks in the data bits, synchronised by the baud rate generator. The data, up to about 20 bytes per RS232 channel, is then buffered in IC24. At the same time, IC24 receives commands (and sends reports) via the serial link with IC18 which is controlled by IC23. When IC24 receives a command from IC18 to empty one of its buffers, it does so, down the serial link via IC23.

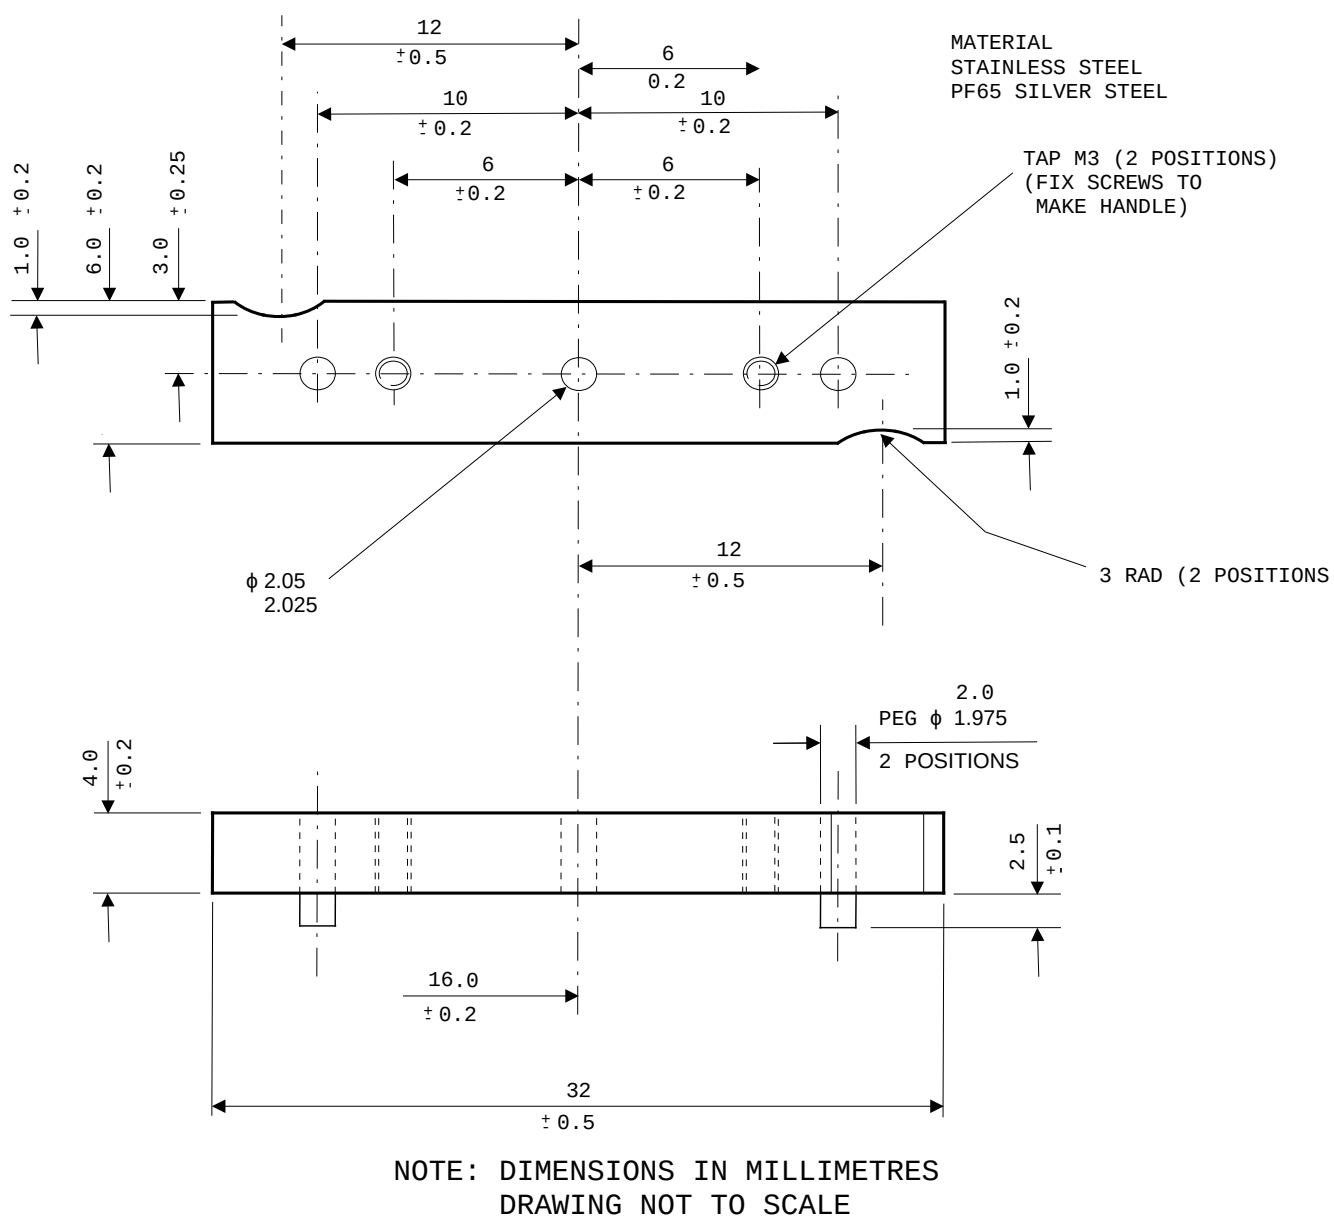
Figure 4.1 MOTOR LOCATION JIG

EQUIPMENT	SPECIFICATION/MANUFACTURER
Oscilloscope with probe (x10)	Rise time : 0.02 us/cm
Multimeter	General purpose
Colour Television	Open market
New microdrive cartridges	as required, Sinclair
Head cleaner	Open market
Double-sided adhesive tape	Open market
Extension ribbon/connectors for J11,J12 and front panel	Make up on site
LED wiring (to enable operation with cover off)	
ZX Microdrive	Sinclair
Motor location jig	See Figure 4.1

- 2.2. Roller: The motor drive roller should not be distorted in any way and should have the specified gap between it and the collar beneath it.
- 2.3. Motor Position: If not correct, this can cause tape slipping and speed problems. If these problems exist, check position using the appropriate jig.

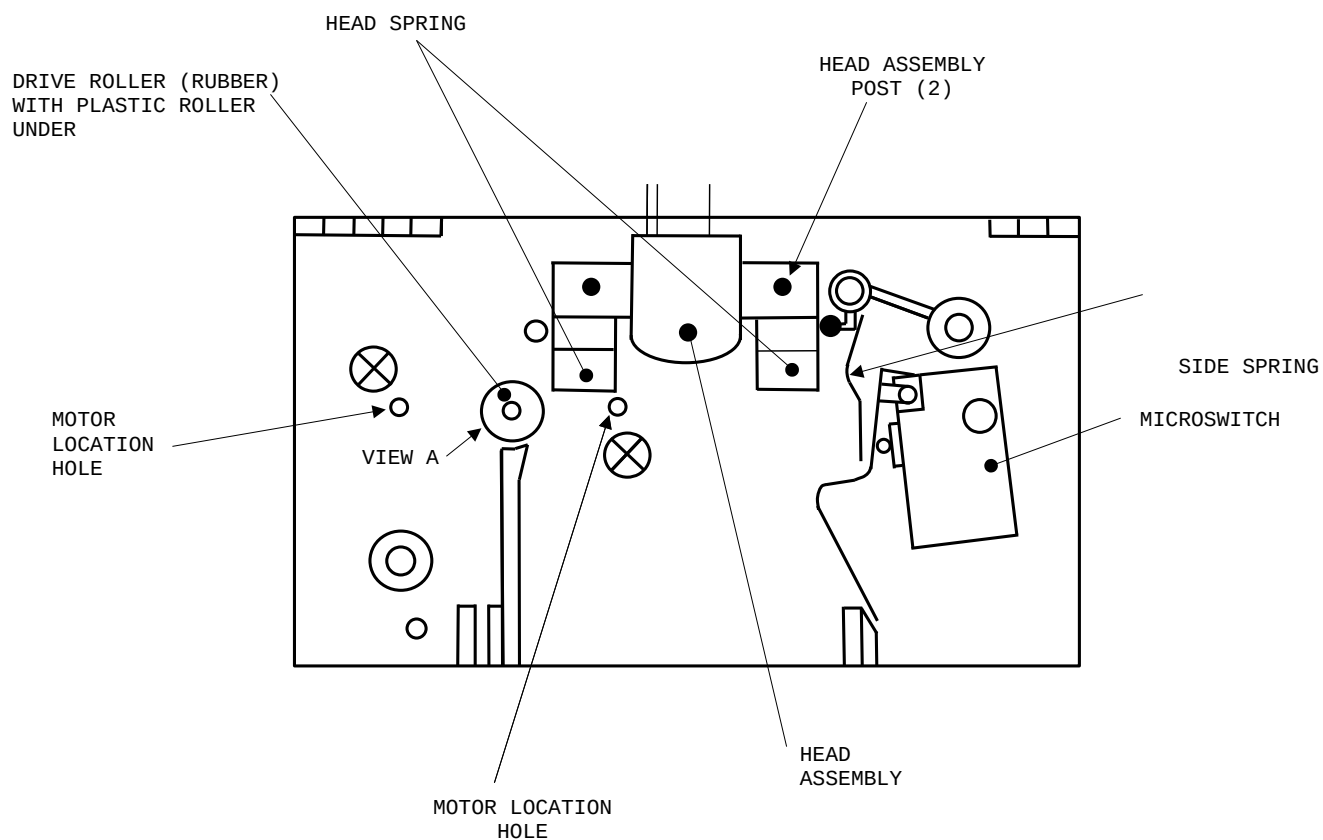
FIGURE 4.3 HEAD CHASSIS

- 2.4.1 The microdrives have been a source of some problems in the pre-Issue 6 units. The mechanical layout is shown in Figure 4.3. Note that it is not possible to replace the read/write head on the microdrives, but all other components are replaceable. If the system test indicates a microdrive failure, the indicated microdrive, MDV1 or MDV2, must be further investigated. Where the fault finding guide (para 2.4) indicates microdrive failure, refer back to this paragraph.
- 2.4.2 Establish that on-board voltages are correct by carrying out the checks set out in the table below. Circuit references are for MDV1 (with MDV2 references in brackets).

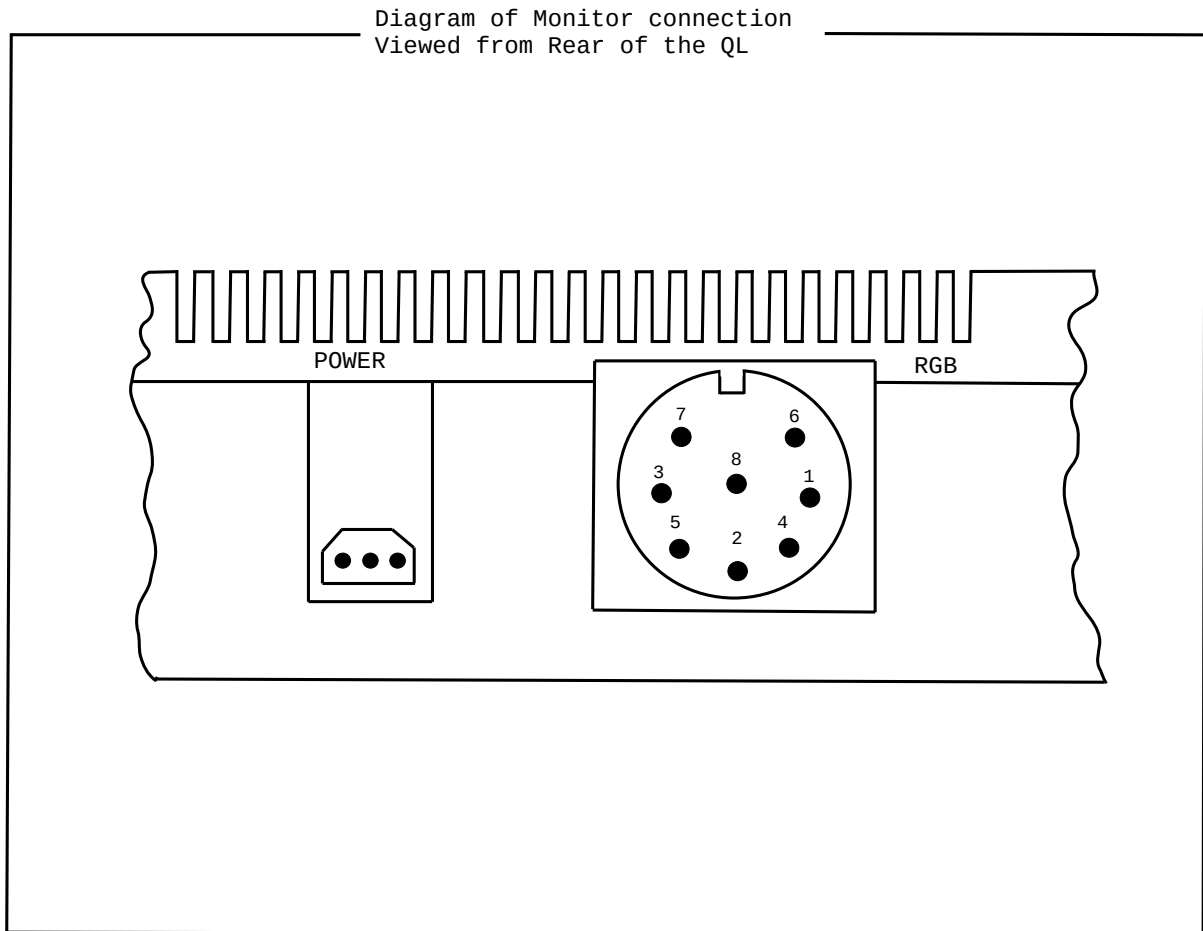
- 1.4. An RGB (colour) monitor can be connected using a lead with an 8-way DIN plug at the QL end. The connection at the monitor end varies according to the monitor (there is no industry standard) and is often supplied with it. A suitable cable with an 8-way DIN plug at one end and bare wires at the other end is available from Sinclair Research Ltd.

- 1.5. A composite PAL monitor, or the composite video input on some VCRs may work with the QL. Only pins 2 (ground) and 1 (composite PAL) need to be connected via a cable, to the monitor or VCR.

Pin	Function	Signal	Wire Colour	Signal Level
1	PAL	Composite Pal	Orange	1V pk-pk into 75 ohm
2	GND	Ground	Green	
3	VIDEO	Composite Mono Video	Brown	1V pk-pk into 75 ohm
4	CSYNC	Composite Sync	Yellow	0 to 5V TIL (active low)
5	VSNC	Vertical Sync	Blue	0 to 5V TIL (active high)
6	GREEN	Green	Red	0 to 5V TTL (active high)
7	RED	Red	White	0 to 5V TIL (active high)
8	BLUE	Blue	Purple	0 to 5V TIL (active high)

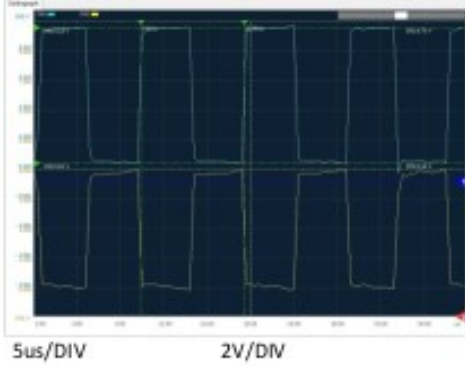
Fig D1

100 KHZ WRITE DATA 1 AND 2

MICRODRIVE SIGNALS (100 KHZ WRITE)

- 1.4. The program 'SIGNAL TEST' sends 100KHz to a microdrive in write mode, (erasing Simultaneously) then puts it in read mode so that signals returned can be observed. This enables the performance of electronics and mechanics to be assessed with a steady waveform on an oscilloscope.

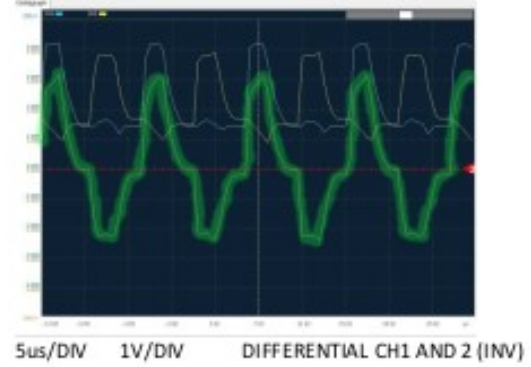
Fig D2

ULA PINS 4 AND 5: WRITE 100 KHZ

DIFFERENTIAL CH1 AND 2 (INV)

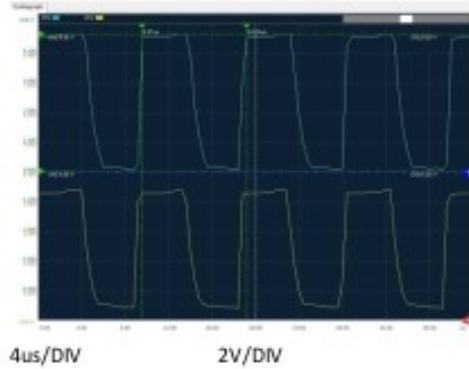
Fig D3

DATA 1 AND 2: DURING READ 100 KHZ

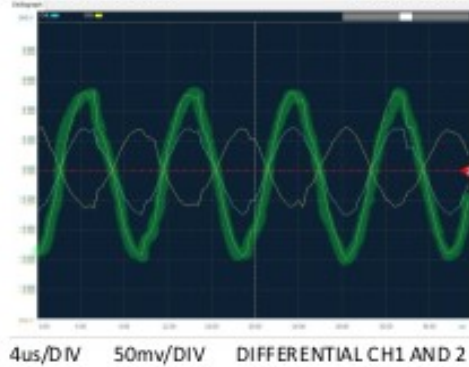
Fig D4

ULA PINS 4 AND 5 READ 100 KHZ

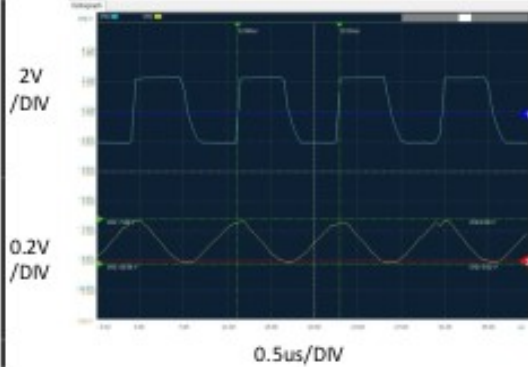
Fig D5

DATA 1 AND ULA PIN 2 READ 100 KHZ

MICRODRIVE SIGNALS (100 KHZ READ)

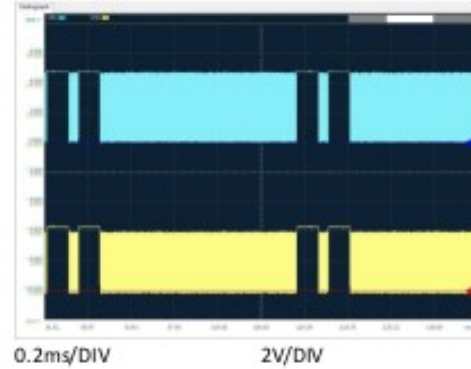
Fig D6

DATA 1 AND 2 : DURING FORMAT (READING)

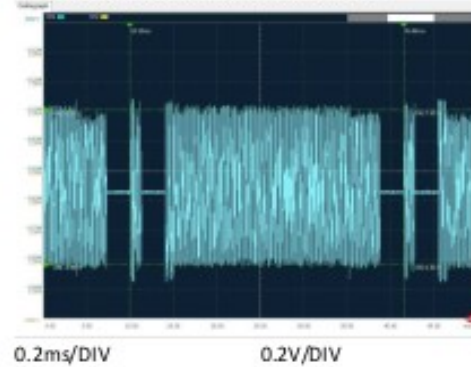
Fig D7

ULA PIN 1 : DURING FORMAT (READING)

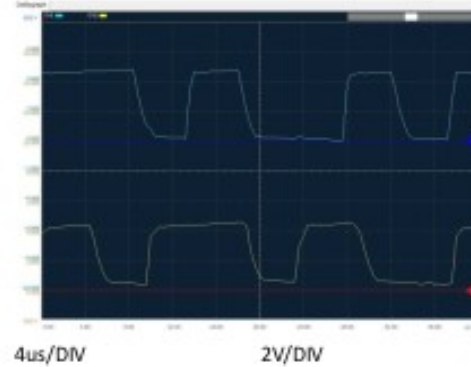
Fig D8

DATA 1 AND 2 : DURING FORMAT (READING)

MICRODRIVE SIGNALS (FORMAT READ)

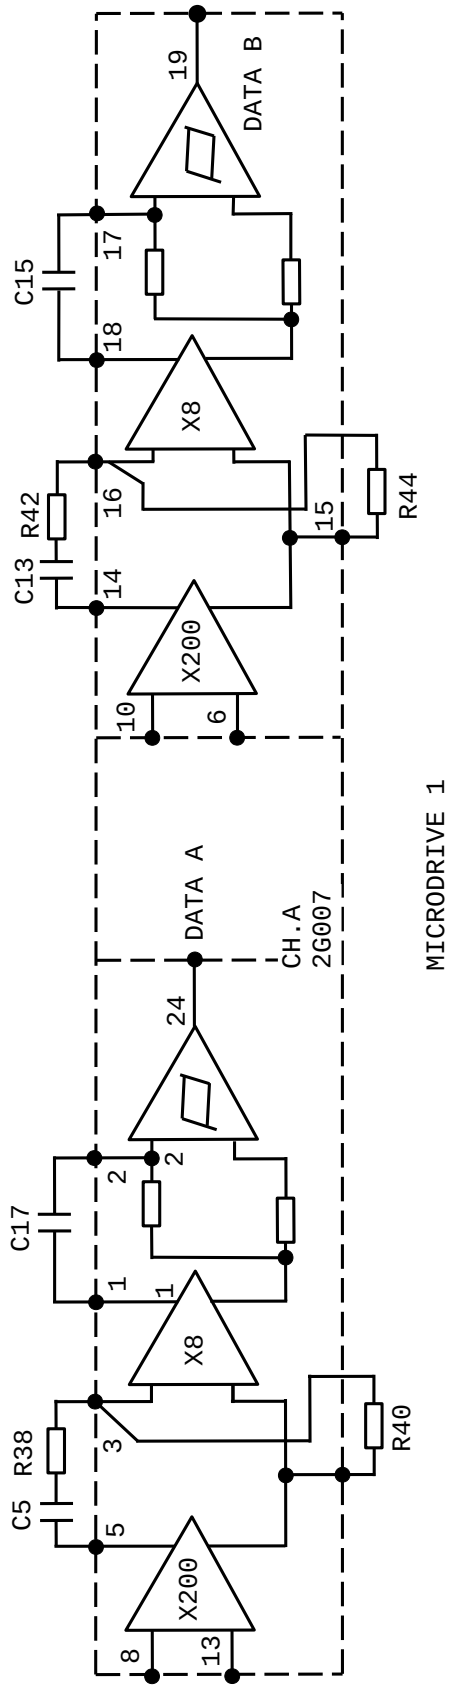
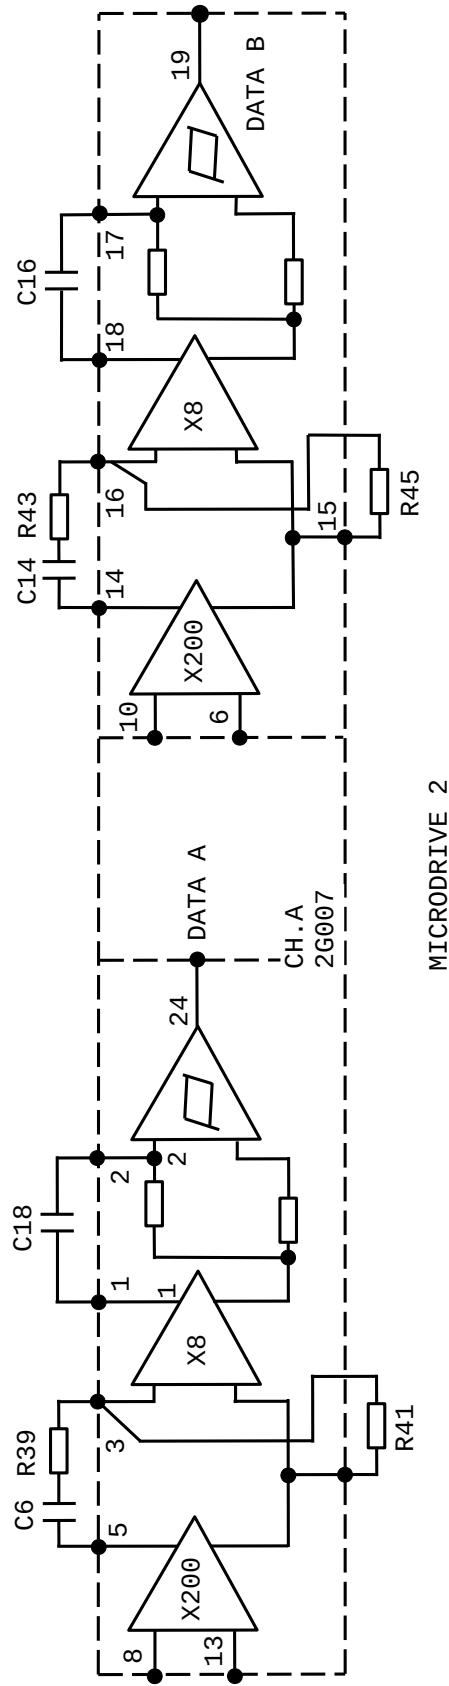
FIG D9 ULA 2G007 - INTERNAL CIRCUIT

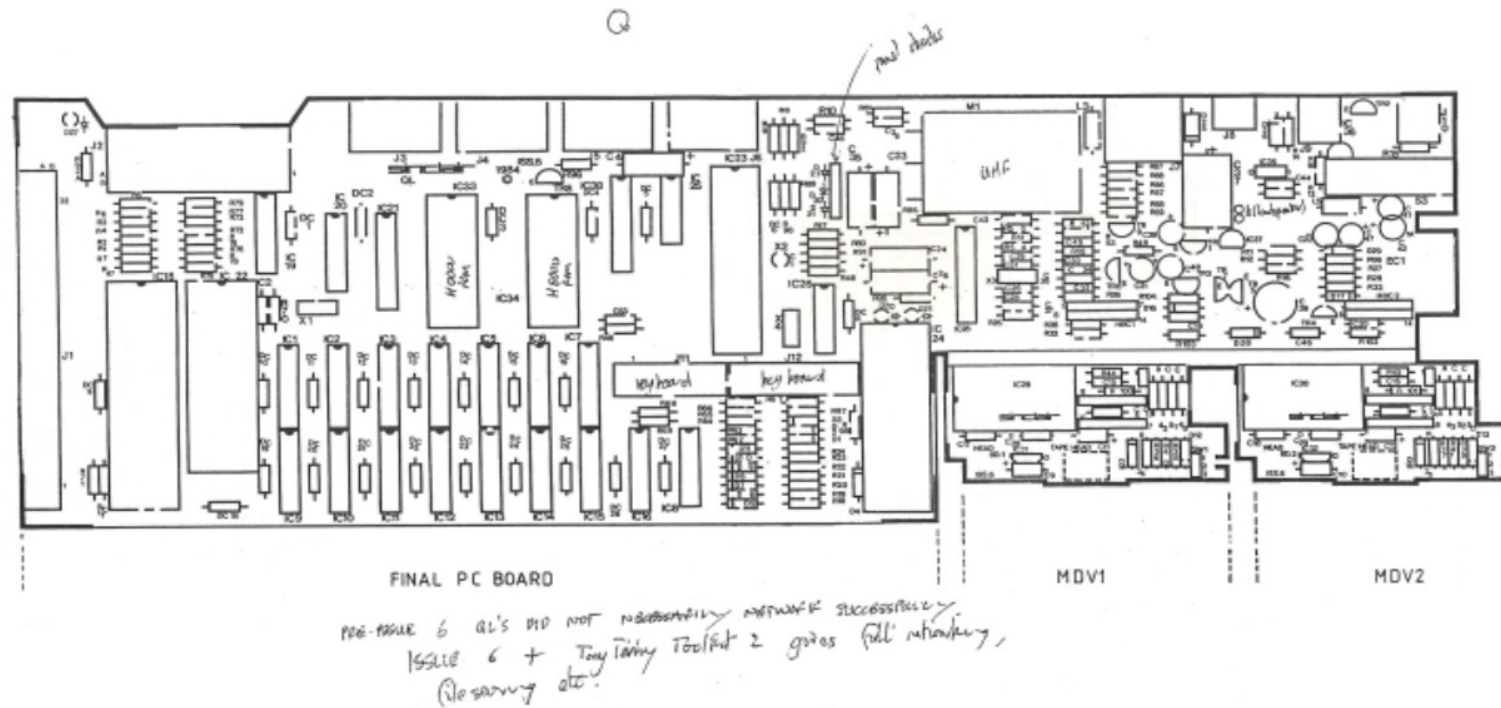
PRINTED CIRCUIT BOARD (Issue 6) FIGURE 5.2
 COMPONENT LAYOUT

COMPONENT SIDE LAYOUT

1.2.2 A newly laid out P.C.Board was introduced at Issue 6 to reflect the removal of IC17 and IC27 and the addition of HAL IC38. Resistors R102, R103 and R104 were added at this stage and trimming capacitor TC1 was replaced with a fixed capacitor C53 of 22pF. The parts list reflects minor changes to component values. Board layouts are shown in Figures 5.1 and 5.2.
